Crook County F & R - Powell Butte Station

Croo_fir03A

FEMA 154 Rapid Visual Screening Score Card

Croo_fir03B

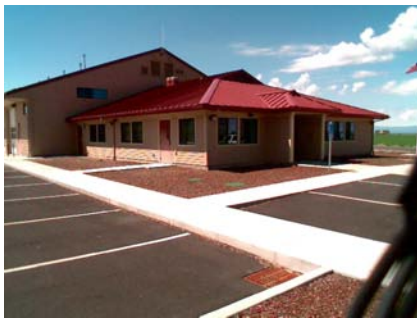
Plan Irregularities	Vertical Irregularities
Reentrant Corners:T shaped (Adjacent Build/Entity)	Steps in Elevation View: Single Change (Adjacent Building/Entity)
None	None
None	None

NE Plan Irregularity Primary

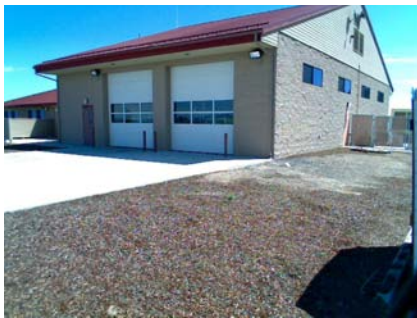
SW General Site
